Research Article

Spatial Determinants of Recurrent Landslides Revealed Through Multi-Source GIS–Remote Sensing Integration in Kindo Didaye, Wolaita Zone, Ethiopia

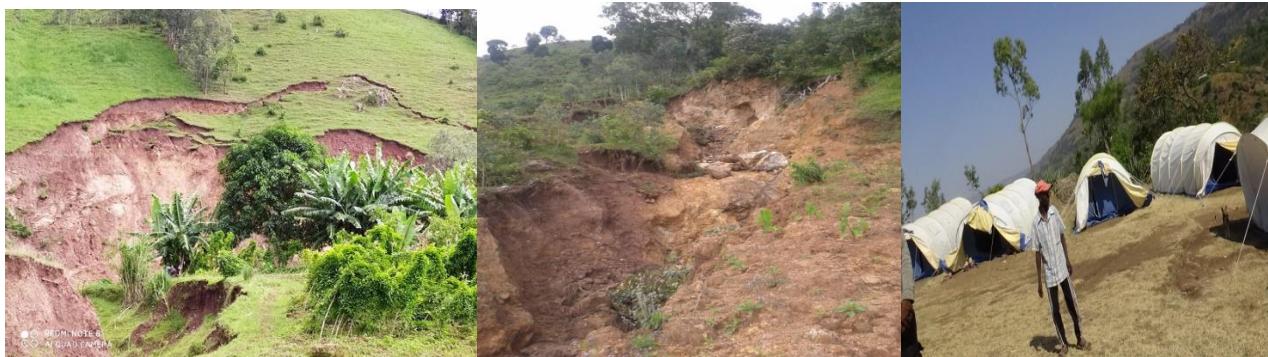
In addition to FGD and KIIs information, the observation done by research team on landslide prone area clearly indicated that there was poor landscaping and inappropriate farmland management practice resulted in frequent landslide occurrence in study area. Furthermore, topographic condition, geology (unconsolidated soil

condition), and road construction (deep hill side cutting) aggravated landscape failure and recurrent landslide occurrence.

Figure 12. Landslide picture taken during Field observation at Zebo(Galaza), 2021

Therefore, aforementioned situations in study area demands high level intervention with modern landscaping (stone bund, soil bund, bench terrace, graded fanaya juu terrace, normal fanaya juu terrace, gabion etc) as well as introduction of appropriate farming practice and farming community income diversification.
